The Sinking of the First Rate *Victory* (1744): A Disaster Waiting to Happen?

Sean A. Kingsley

Wreck Watch Int., London, UK

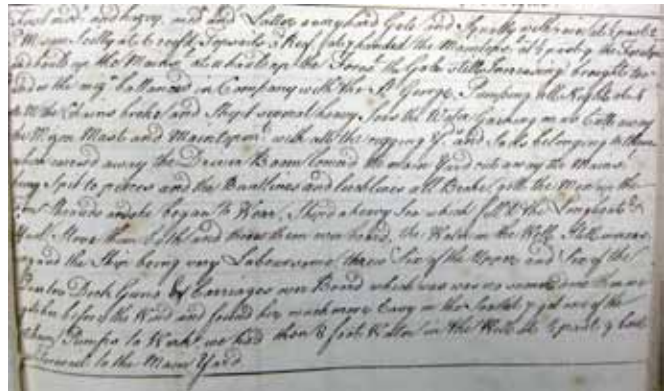
Fig. 3. The captain's log for 3 October 1744 for the Fourth Rate *Exeter* (ADM 51/326) that was almost lost during the storm that sank the *Victory*.

The Fourth Rate *Exeter*, only launched in March 1744 (Winfield, 2007: 126), was the most serious casualty other than the *Victory*. The ship spotted the Scilly Isles at 2.30pm on 3 October, after which the weather turned from moderate and hazy to a very hard gale and squally with rain. On the morning of 4 October (ADM 51/326), the captain logged that (Fig. 3):

Pumping all Night at 4 a:m the Chains broke and Shipt several heavy Seas the Water Gaining on us Cutt away the Mizon Mast and Maintopmt: with all the rigging yds. and Sails belonging to them which carried away the Driver Boom... the main Yard cut away the Mains: being Spit to pieces and the Buntlines and leechlines all Broke, gott the

men up the Fore Shrouds and she began to Wear, Ship'd a heavy Sea which fill'd the Longboat and Yaul, Stove them both and threw them over board, the Water in the Well still increasing and the Ship being very Laboursome, threw Six of the Upper and Six of the Quarter Deck Guns & Carriages over Board which was no sooner done than we got her before the Wind and found her much more Easy in the Sea. at 7 got one of the Chain Pumps to work, we had then 8 foot Water in the Well at ½ past 9.

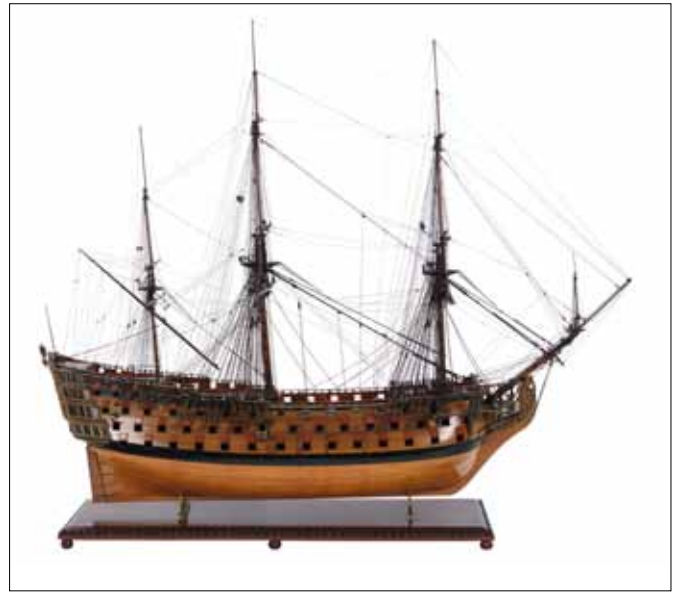
Fig. 6. A contemporary full hull model of the First Rate *Victory* (launched 1737). Photo: National Maritime Museum, Greenwich, SLR0449.

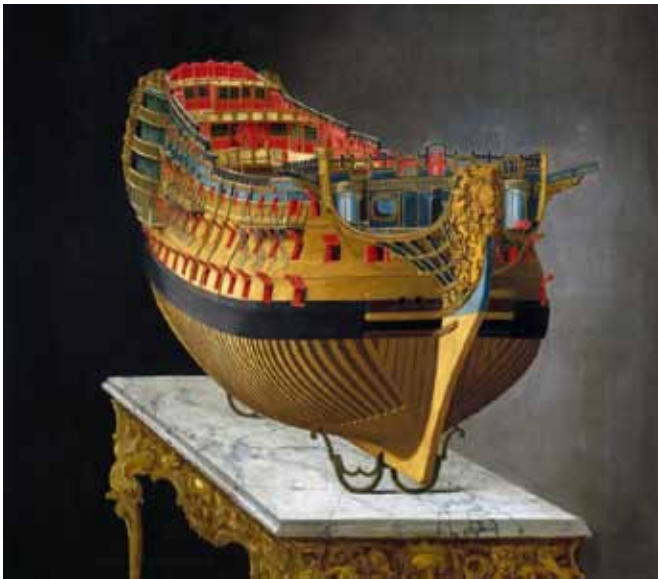
Figs. 7-8. Perspective paintings of a model of the First Rate Victory 1744, formerly in the collection of King George III. Photo: Science Museum Group, 1864-12/2.
