The Sinking of the First Rate *Victory* (1744): A Disaster Waiting to Happen?

Sean A. Kingsley

Wreck Watch Int., London, UK

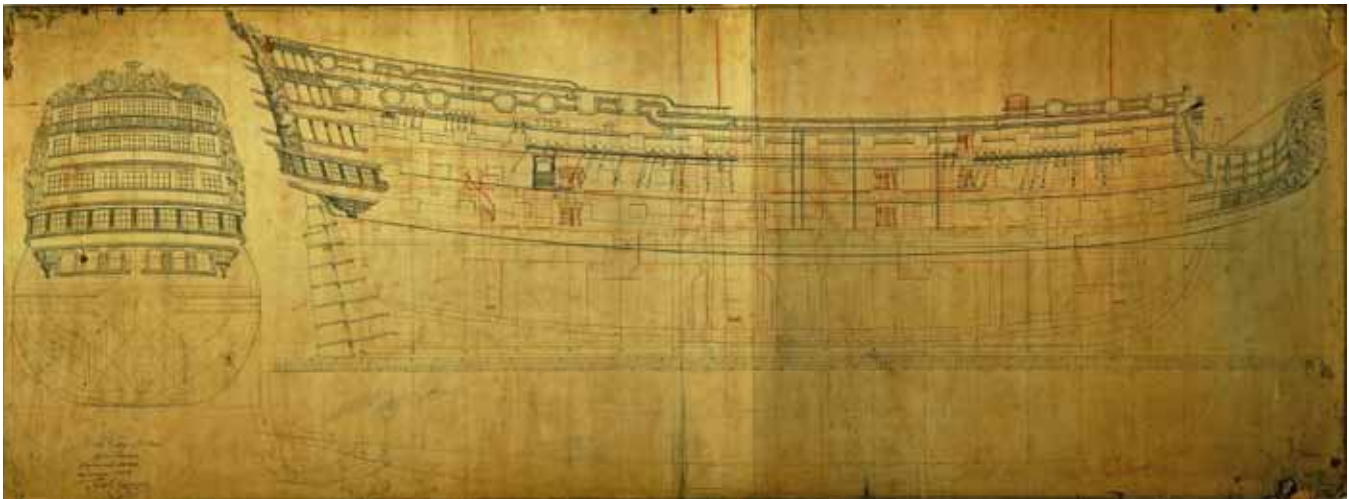
Fig. 4. Plan of the body and stern decoration of the First Rate *Victory* (launched 1737), copied by Frederick Chapman c. 1754. Photo: National Maritime Museum, Greenwich, ZAZ0145.

The escutcheon and taffarel-standards on the *Victory's* poop-royal formed part of her framework, and unusually elevated the height of the poop 2.52ft higher above the gundeck than on the *Royal-Louis*, a First Rate warship of 124 guns built by Ollivier at Brest. In general, English First Rates of 100 guns were built about 9ft shorter than the French equivalents, such as the *Royal-Louis* and *Foudroyant* of 110 guns. Meanwhile, the French Master Shipwright determined at Woolwich that the 90-gun *Duke* under construction during his visit was scarcely larger than a French ship of 74 guns, was too full at the stern and too slight forward. French vessels were characterized by a great difference in the depth of the hold, ranging from one-eighth to one-tenth deeper than English warships. Ollivier was informed by English shipbuilders that the preference for iron ballast on English warships, in contrast to France, stiffened the hull and counteracted the movements of a ship, especially rolling (Roberts, 1992: 61, 132-33, 135-36, 167).

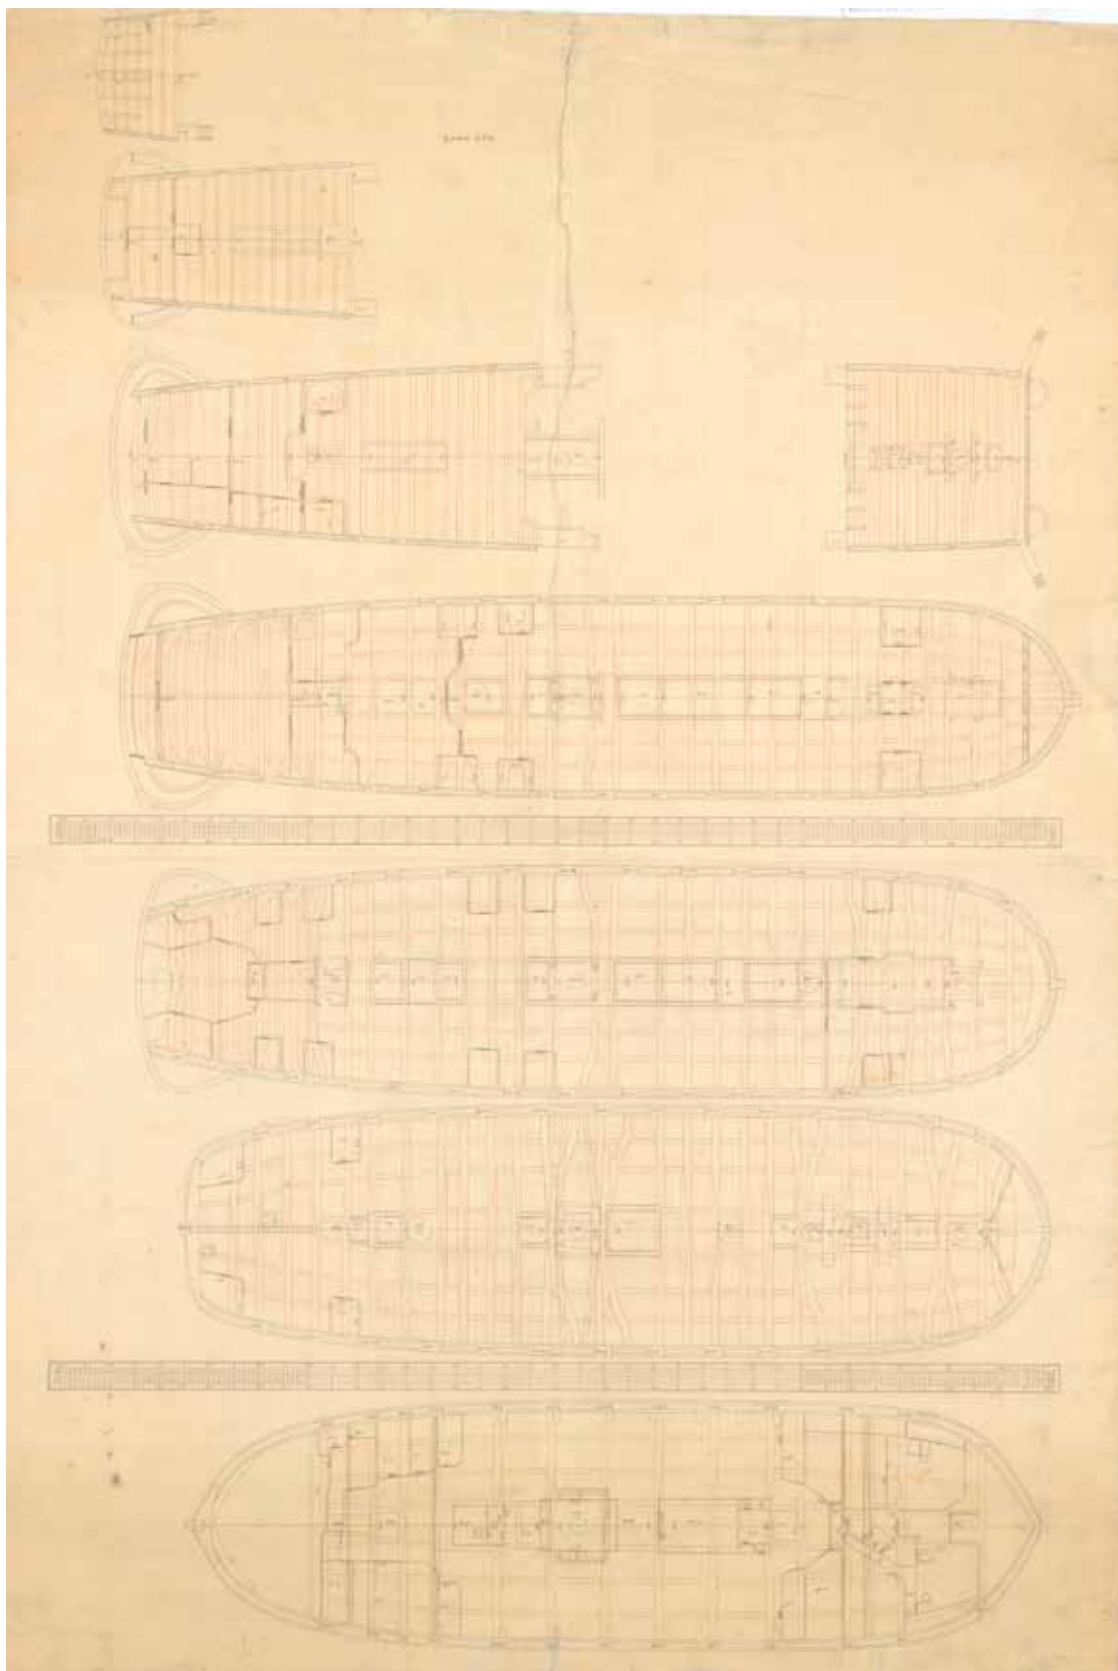
Fig. 5. Plan showing the poop deck, quarterdeck, forecastle, upper deck, middle deck and lower deck of the First Rate Victory (launched 1737). Photo: National Maritime Museum, Greenwich, ZAZ7847.

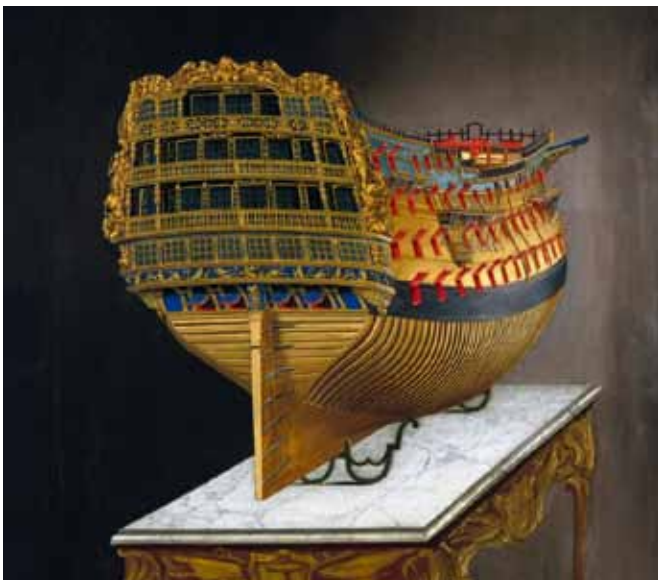
Figs. 7-8. Perspective paintings of a model of the First Rate Victory 1744, formerly in the collection of King George III. Photo: Science Museum Group, 1864-12/2.
